INITIAL STUDY

PROJECT FILE NO.: PDC07-009, PD07-010, PT07-051 and Subsequent Permits

PROJECT DESCRIPTION: Planned Development Rezoning from LI-Light Industrial Zoning District to A(PD) Planned Development Zoning District to allow 2,800 square feet of commercial uses and up to eight residential units in a mixed-use development on a 0.24 gross acre site

PROJECT LOCATION: Southeast corner of the intersection of The Alameda and Bush Street

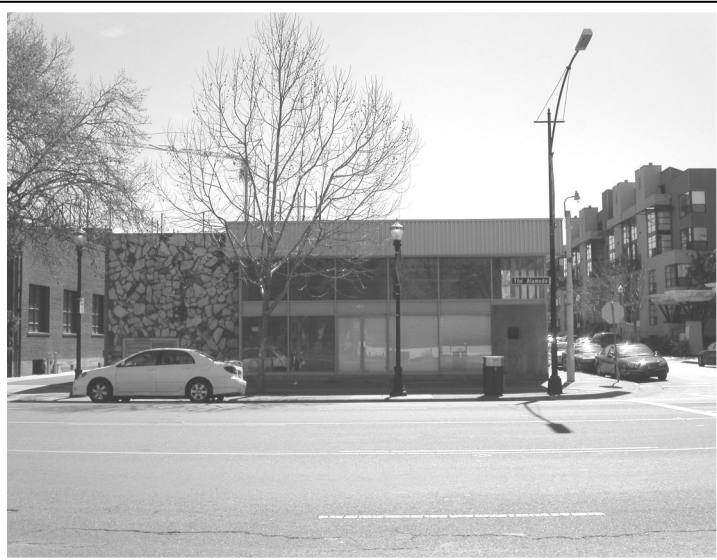
P5a. Photo or drawing (Photo required for buildings, structures, objects.)

P5b. Description of Photo: (View, date, accession #)
View of the front façade of the structure at 746 The Alameda

*P3a. Description: (Describe resource and its major elements. Include design, materials, condition, alterations, size, setting, and boundaries.)
The structure at 746 the Alameda is a single story commercial building in good to fair condition. The structure is of tilt-up reinforced concrete construction. The roof is flat, without eaves. The exterior walls for the majority of the structure consist of concrete, painted a light gray. A modernist front façade, containing a cantilevered overhang, ribbons of plate glass windows, and a natural stone finish, adds visual interest to this otherwise utilitarian structure. Multiple roll-up garage doors on the west side of the structure provide vehicular access to the building. The interior of the structure consists of a front entry room, with a single large storage/work area behind. The interior is lacking in architectural detailing.

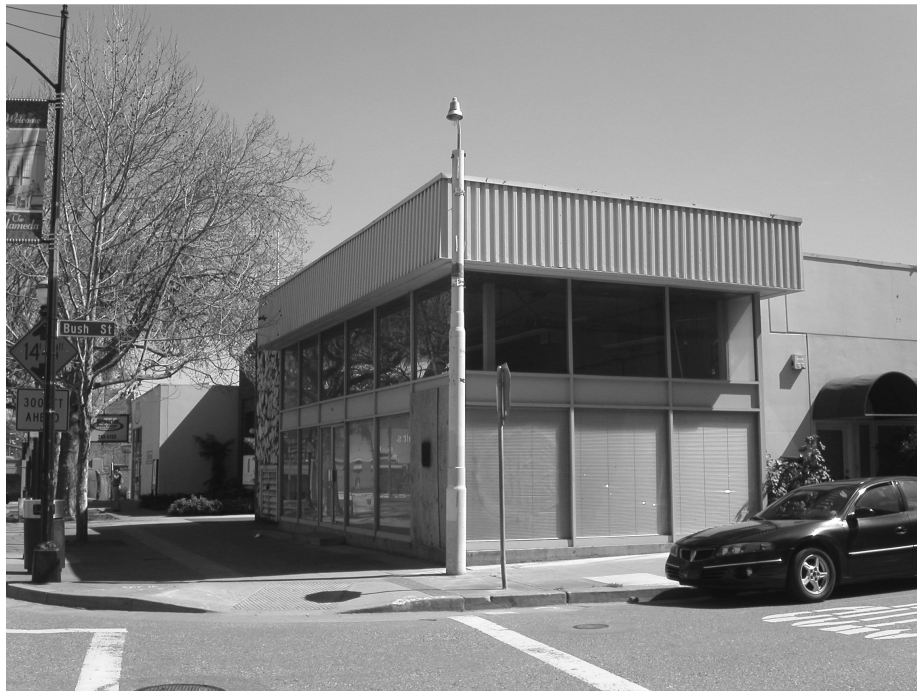
Photo 1: Oblique view of the modernist front façade.

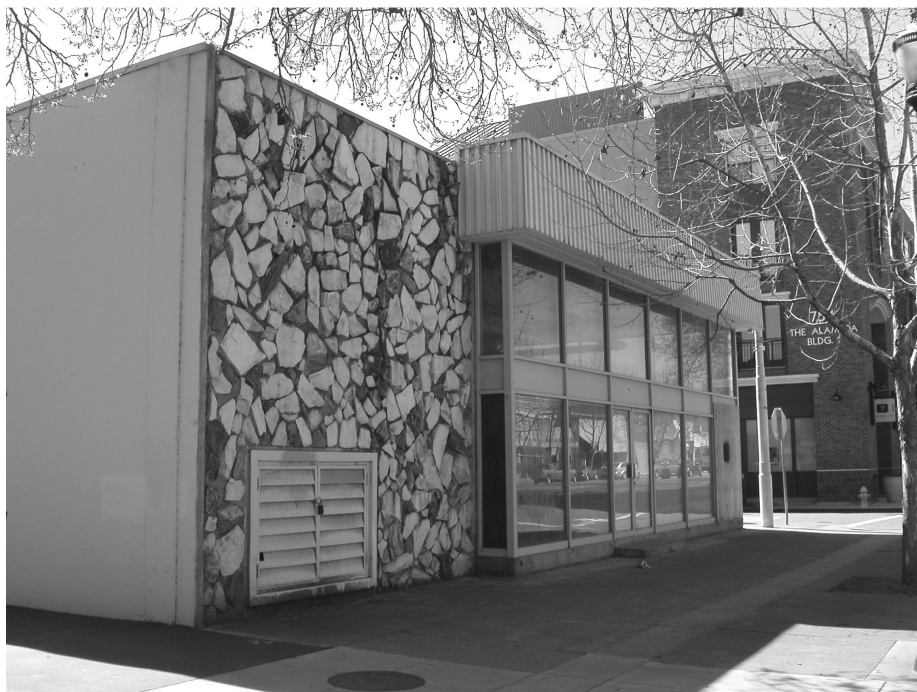
Photo 2: Oblique view of the modernist front façade from the east.

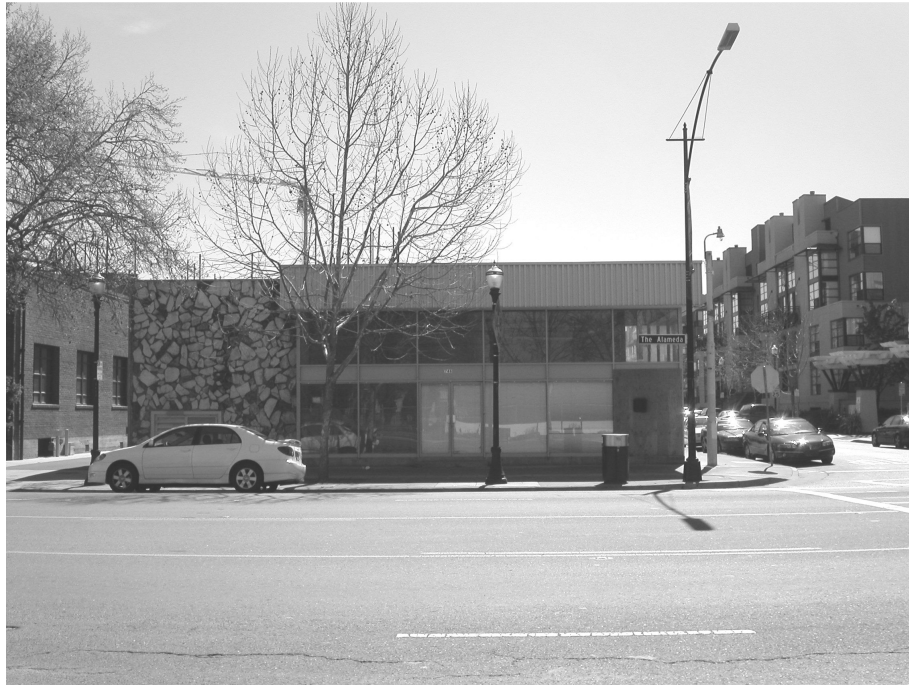
Photo 3: Direct view of the front façade from the north.

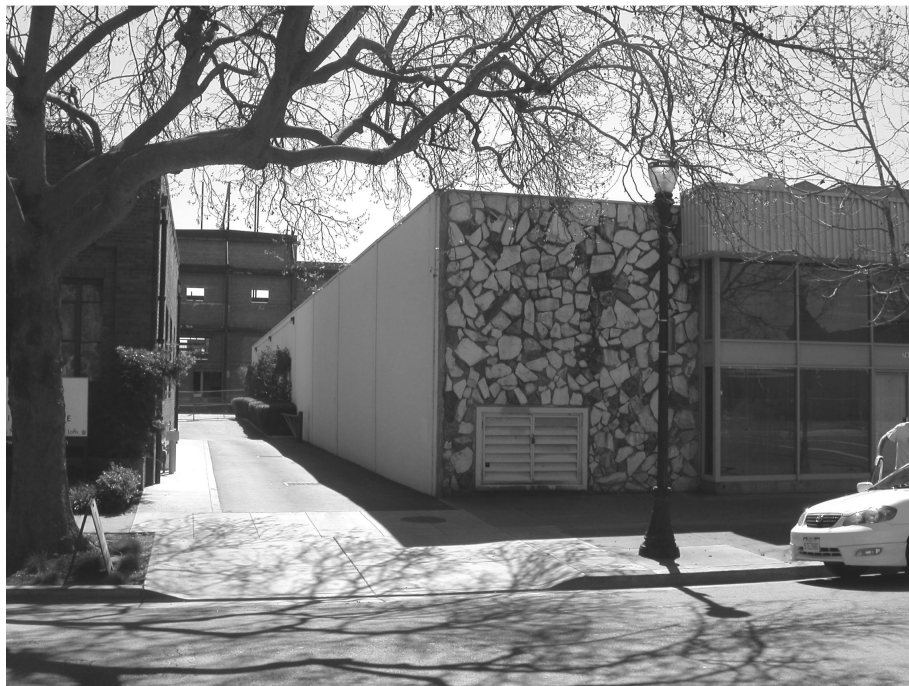
Photo 4: View of the eastern façade along alleyway.

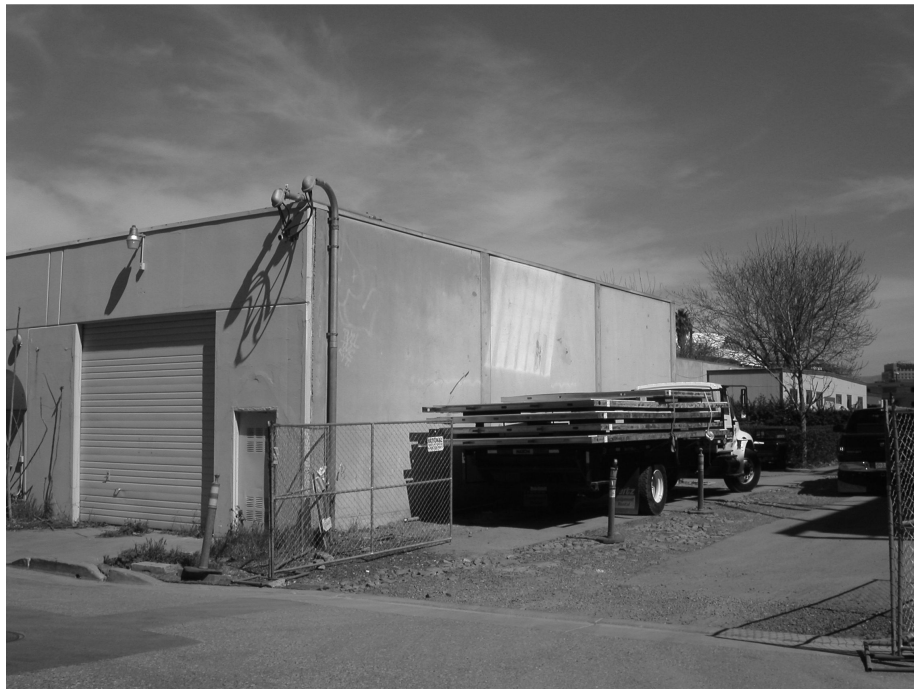
Photo 5: View of the rear façade of the structure.

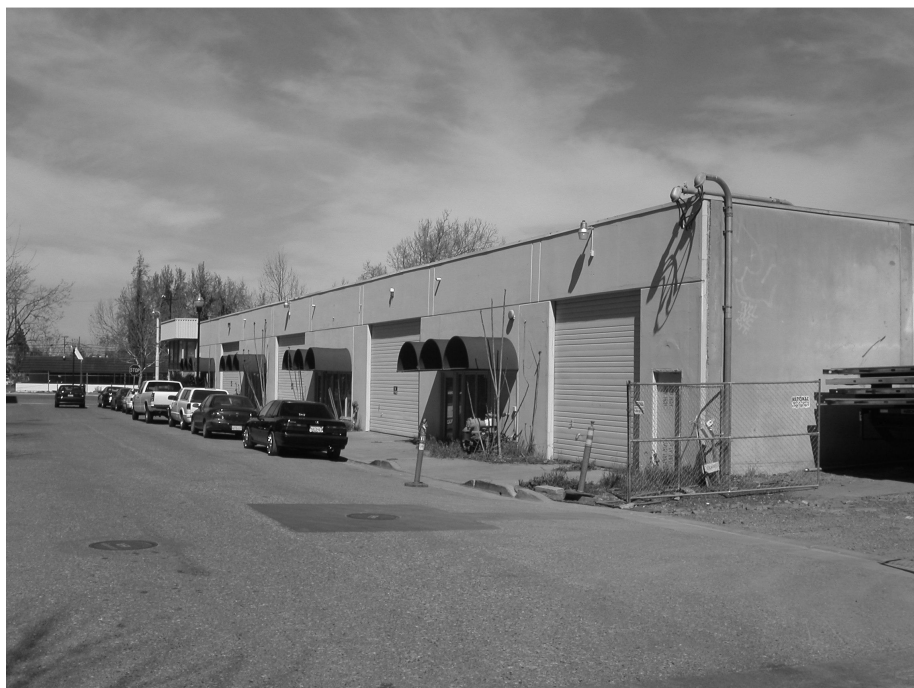
Photo 6: View of the western façade and vehicular access.

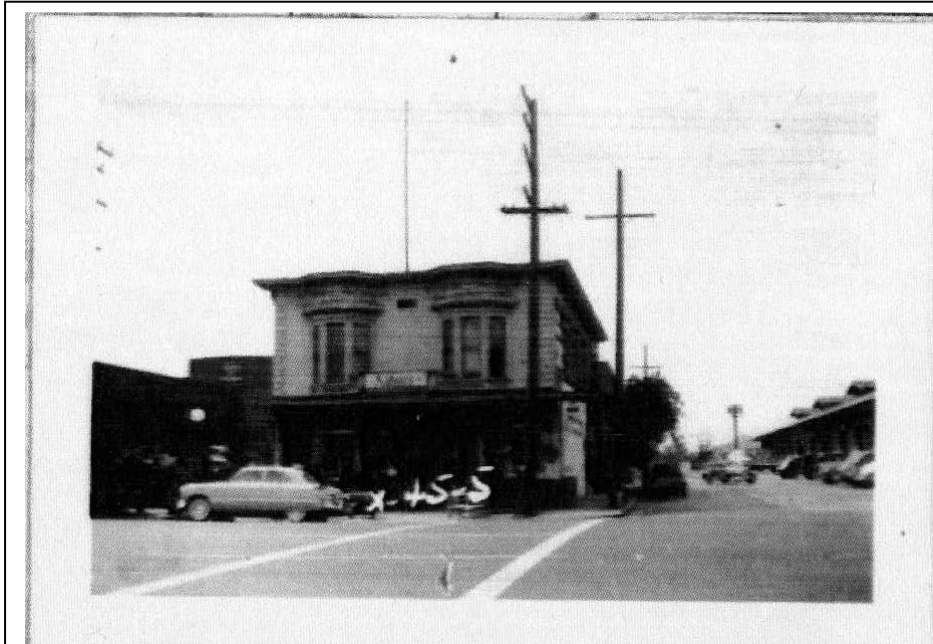
Photo 9: Historic photo of original 1880's structure at 746 The Alameda, taken from appraiser's records.

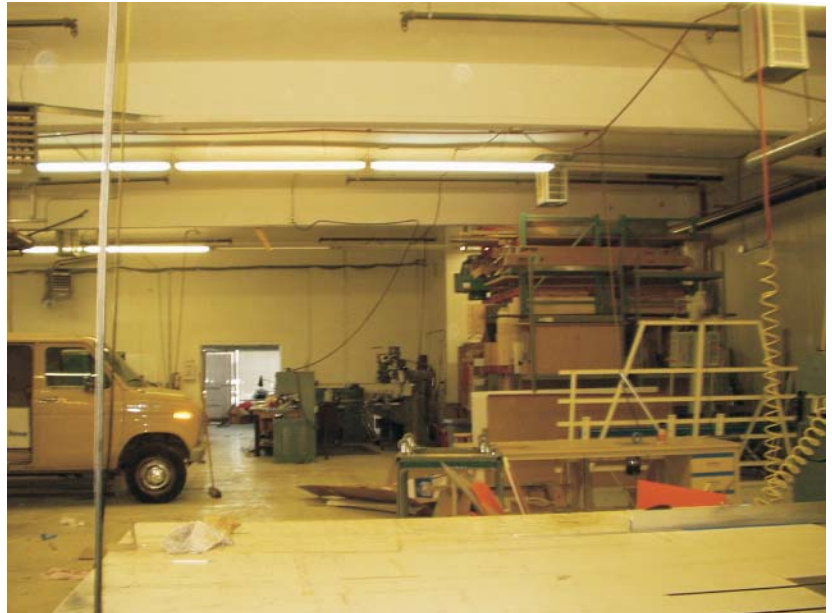
5. Main shop area; doorway into office area is visible in the background.

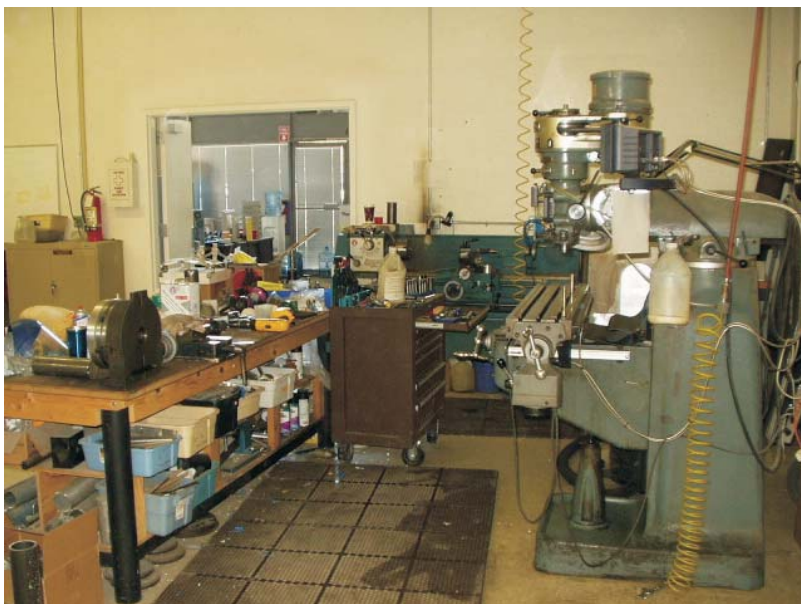
6. Machine shop.

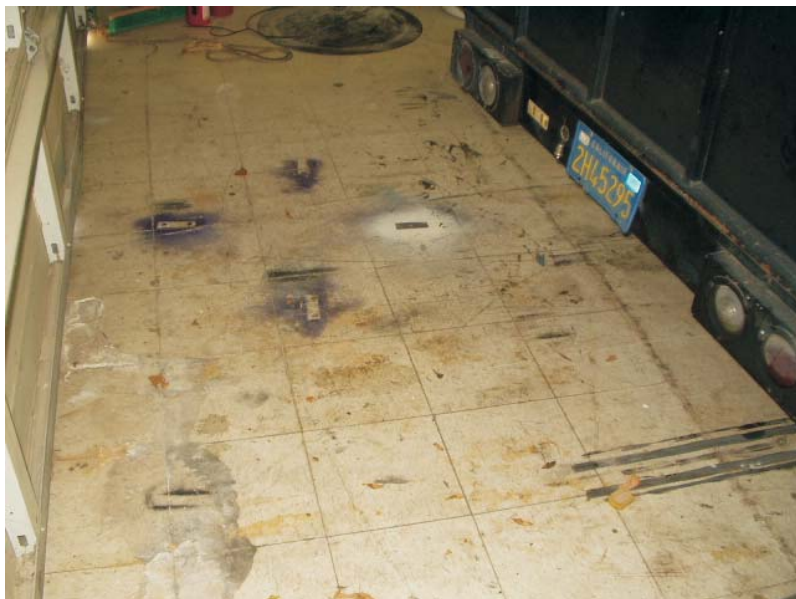
7. Minor staining observed throughout the shop floor.

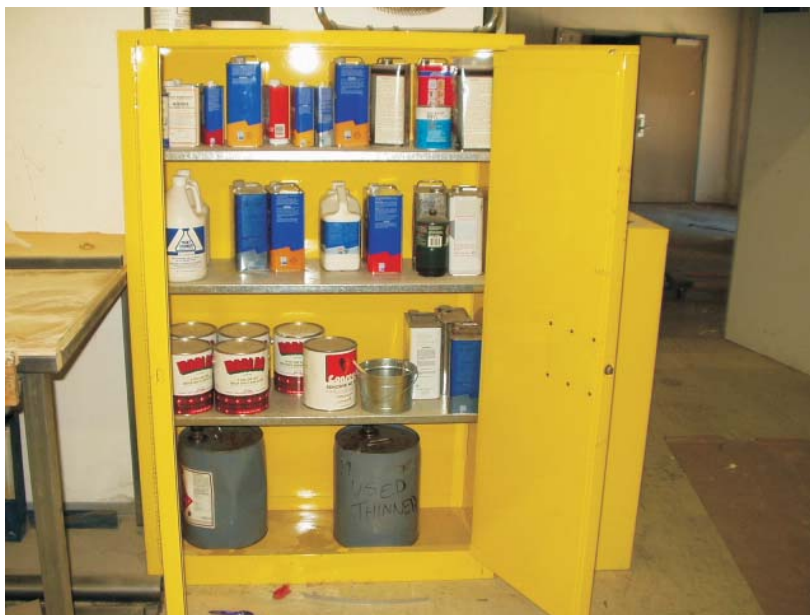
8. Flammable cabinet containing unused and waste paint thinners, lacquer thinners, and acetone.

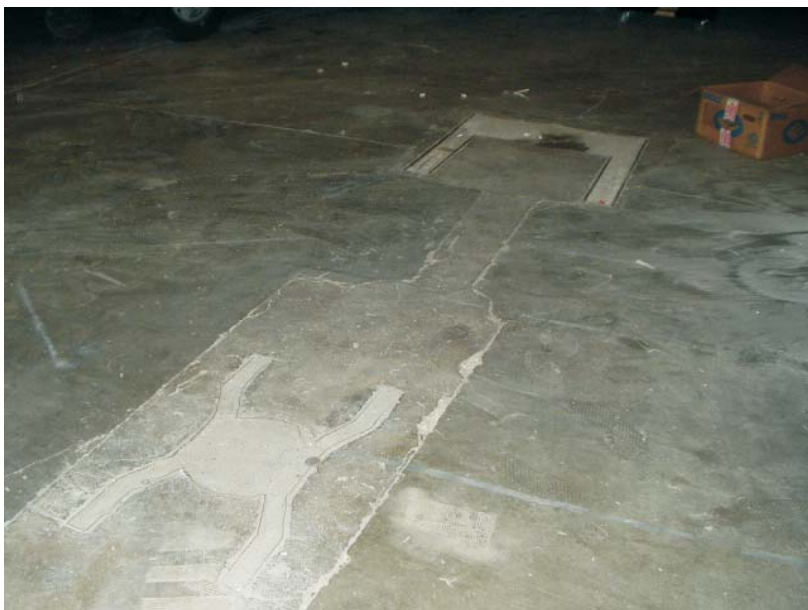
9. View of former belowground hydraulic lift, in the southern section of the warehouse.

- Subsurface remnants of two former hydraulic lifts, left from a historic use of the property for a tire service, were detected. A Phase II Soil Report showed that no traces of hydraulic fluid was present in the soil.
- All surfaces inside the warehouse are paved, and no floor drains, clarifiers, and/or oil-water separators (with the exception of exposed plumbing conduits in the former bathroom area) were observed inside the warehouse. Miscellaneous hazardous materials were used in association with different shop operations performed onsite. With the exception of minor staining observed throughout the warehouse floor, presumably originating from spray painting activities, no evidence of the mismanagement of these materials was observed during the site reconnaissance. The use of these materials onsite is not expected to represent a significant environmental concern.
